## CASE STUDY – MAIN ENGINE BEARING DAMAGE

**Vessel:** MV PANCON BRIGHT

**Service:** Main Engine Bearing Inspection & Technical Support

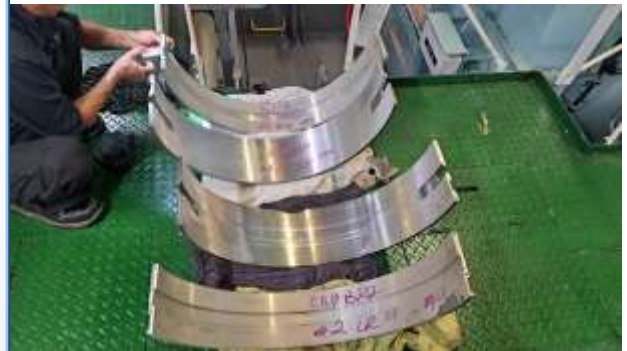
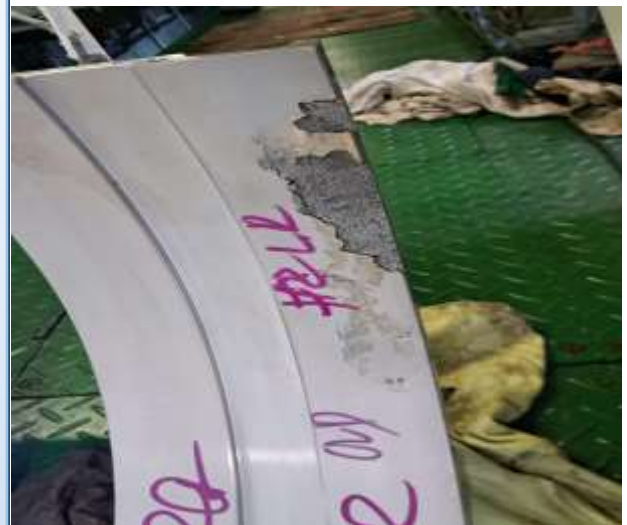
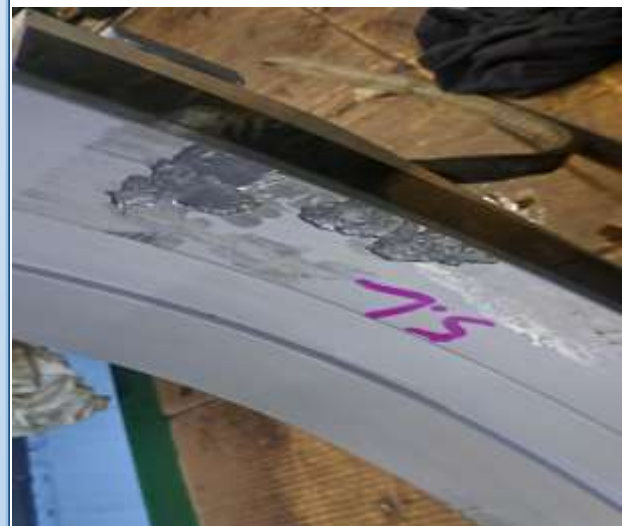
In **December 2025**, during routine cleaning of the **main engine lubricating oil filter**, the crew of **MV PANCON BRIGHT** discovered a significant amount of **metallic debris** accumulated in the filter. The vessel's technical management contacted **MTB Engineering Service** to investigate the condition.

Upon inspection, MTB engineers identified the debris as suspected **bearing material**. The main engine was subsequently opened for detailed inspection, revealing that **bearing shells No. 1, 2, 3, 4 and 5** had suffered **abnormal wear and damage**.

Based on the inspection findings, the bearing damage was suspected to be related to the **quality or service performance of the bearing material**, rather than incorrect lubricating oil or a malfunction of the lubrication system.

MTB recommends using **high-quality bearings** that comply with the engine manufacturer's technical requirements and selecting **suppliers with proven experience and expertise in the marine industry**.

For critical components such as main engine bearings, purchasing decisions should not be based solely on **low price**. Regular inspection of the lubricating oil filter should also be maintained to detect metallic debris and abnormal wear at an early stage.
