## MTB ENGINEERING SERVICE CO, LTD

### STERN TUBE BEARING DAMAGE

**Vessel Type:** Bulk Carrier

**Service:** Stern tube system

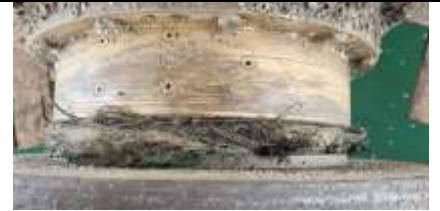
When the vessel arrived at Vung Duc Anchorage, Quang Ninh, MTB's technical team boarded the vessel to carry out the seal bonding work. During the inspection, MTB found a large amount of fishing net entangled around the seal area (Figure 1). When the seal was removed for inspection, water flowed out from inside the stern tube. Considering that this condition could seriously affect the bearing's operating condition, MTB carried out a further inspection and found a significant amount of bearing metal had peeled away from the working surface.

Fig 1. Fishing net entangled around the propeller shaft

After discussing the findings with the vessel's technical team, MTB proceeded with the seal bonding to restore the sealing condition of the system. After completing the work, the vessel resumed its operation and subsequently proceeded to NOSCO dry dock for further inspection of the stern tube bearing.

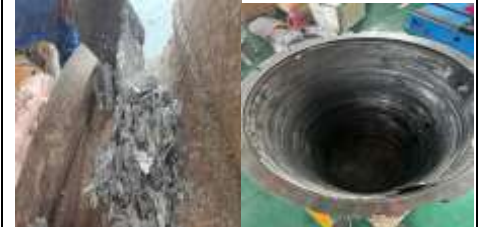
Once the vessel was in dry dock, the stern tube bearing was removed for inspection. The inspection revealed severe bearing damage, with extensive peeling of the bearing metal from the working surface (Figure 2). MTB supplied and installed a new stern tube bearing. To ensure proper system concentricity, MTB performed an alignment check using the LASE method before bearing installation and rechecked the alignment after installation (Figure 3).

Fig 2. Peeling of bearing metal from the working surface.

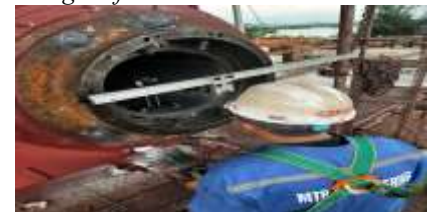
Fig 3. Alignment check after installation of the new bearing.

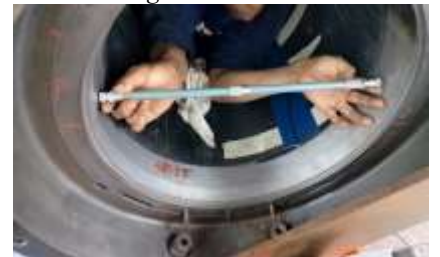
After installation, MTB also measured the internal diameter of the bearing to verify the actual dimensions after installation (Figure 4).

Fig 4. Checking the bearing's internal diameter after installation.

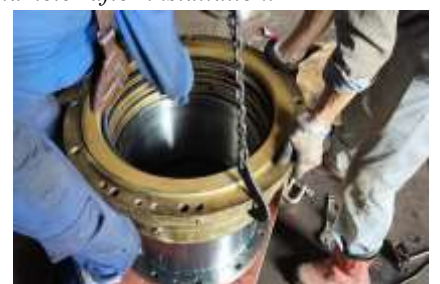
Fig 5. Seal installation at the workshop

- Cleaned and inspected the seal housing;
- Installed a new seal on the system (Figure 5);
- Performed a vacuum leak test of the seal housing at the workshop;
- After completing the installation on the shaft line, performed a seal leak test to verify the sealing performance and operating condition of the system.
