## CASE STUDY – MAIN ENGINE BEARING DAMAGE

**Service:** Main Engine Bearing Inspection & Technical Support

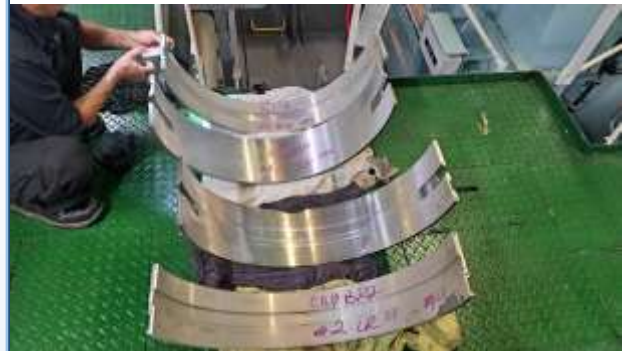
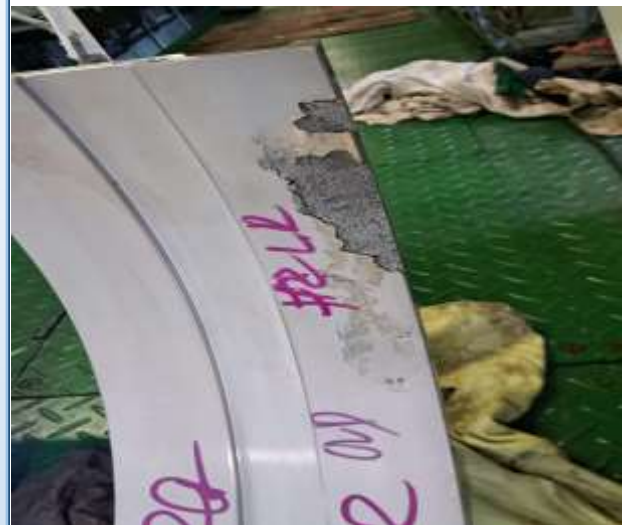
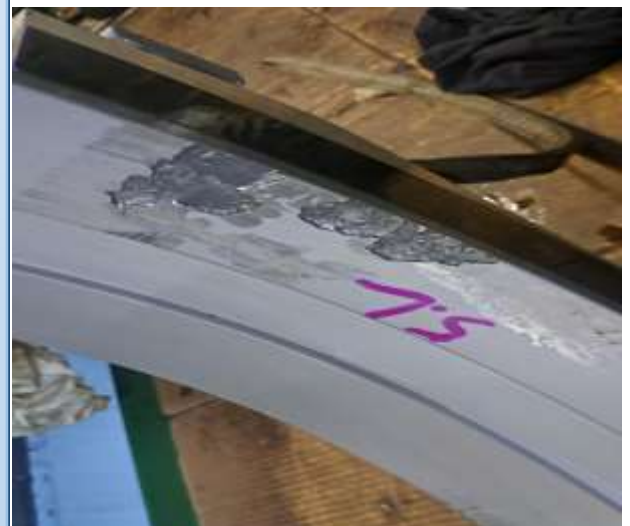
In **December 2025**, during routine cleaning of the **main engine lubricating oil filter**, the crew discovered a significant amount of **metallic debris** accumulated in the filter. The vessel's technical management contacted **MTB Engineering Service** to investigate the condition.

Upon inspection, MTB engineers identified the debris as suspected **bearing material**. The main engine was subsequently opened for detailed inspection, revealing that **bearing shells No. 1, 2, 3, 4 and 5** had suffered **abnormal wear and damage**.

Based on the inspection findings, the bearing damage was suspected to be related to the **quality or service performance of the bearing material**, rather than incorrect lubricating oil or a malfunction of the lubrication system.

MTB recommends using **high-quality bearings** that comply with the engine manufacturer's technical requirements and selecting **suppliers with proven experience and expertise in the marine industry**.

For critical components such as main engine bearings, purchasing decisions should not be based solely on **low price**. Regular inspection of the lubricating oil filter should also be maintained to detect metallic debris and abnormal wear at an early stage.
